City of Somerville — RFP nº 12-71

ADA Self-Evaluation (as basis for Transition Plan)

Prepared by
Institute for Human Centered Design
August 12, 2013

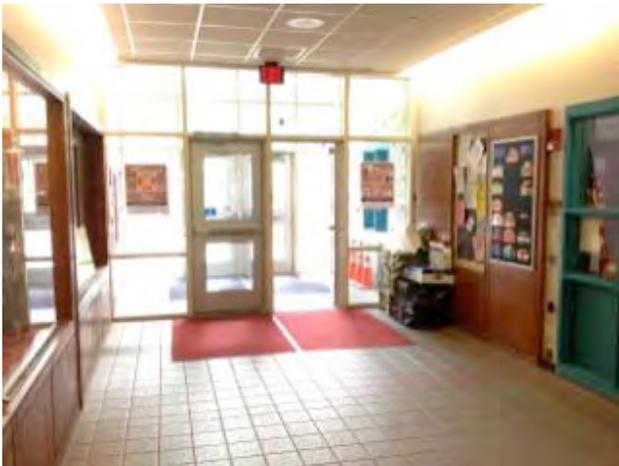
Photo 5

At most entrances and exits as well as certain circulation areas and inside the gym, several weather mats are not secure and can become tripping hazards to faculty and students. (Photo 5)

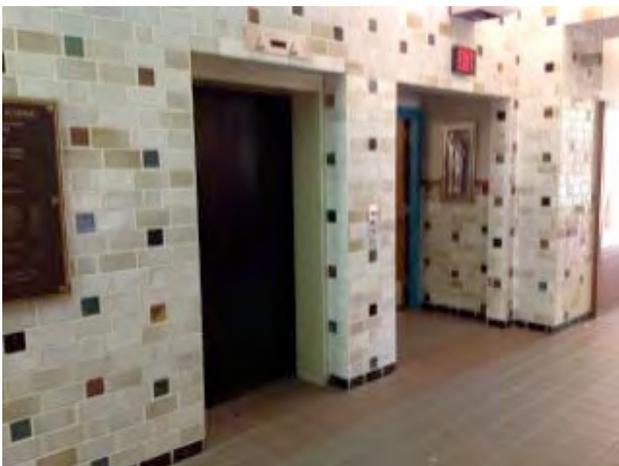
Photo 6

On the first floor, a sign for floor designation is missing on the right jamb of the elevator hoistway entrance. (Photo 6)

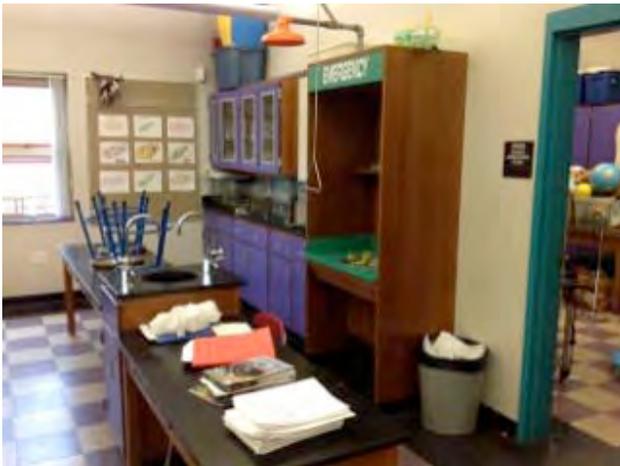
Photo 8

The science lab and art classroom on the second floor lack accessible sinks. (Photos 7 and 8)

Additionally, safety equipment such as blankets, showers, and eye wash stations inside the science lab were blocked by the adjacent sink. (Photo 8)

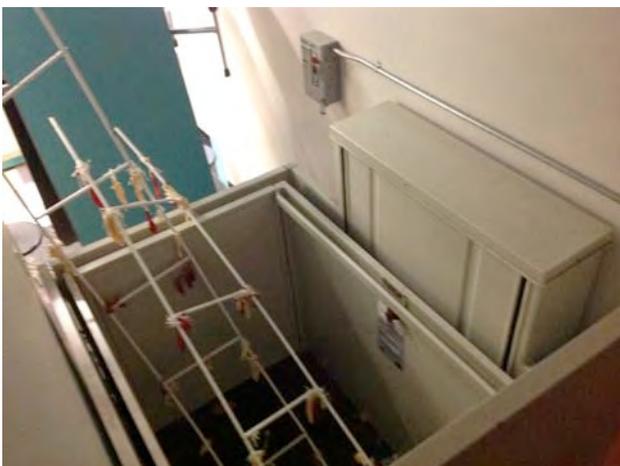
Photo 9

Although a lift is provided to the stage inside the cafetorium, it is obstructed by storage. (Photo 9)

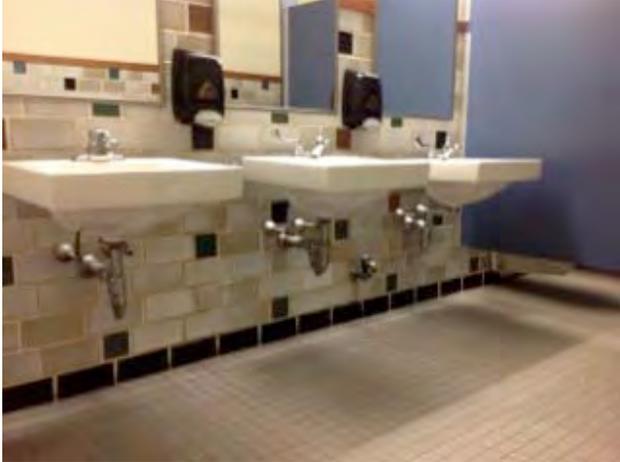
Photo 10

In the multi-user toilet room for student use, plumbing underneath the lavatories is unprotected. (Photo 10)

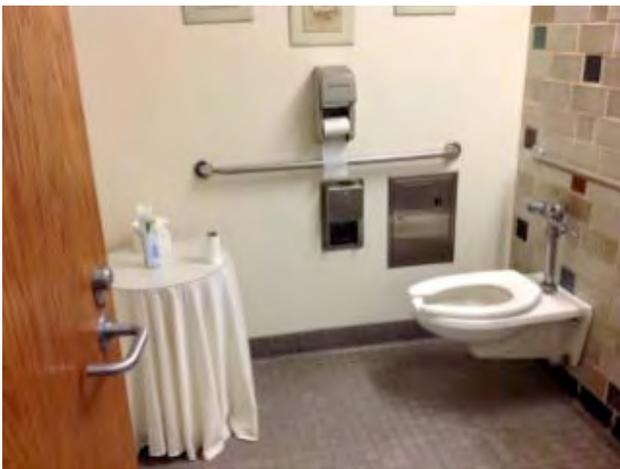
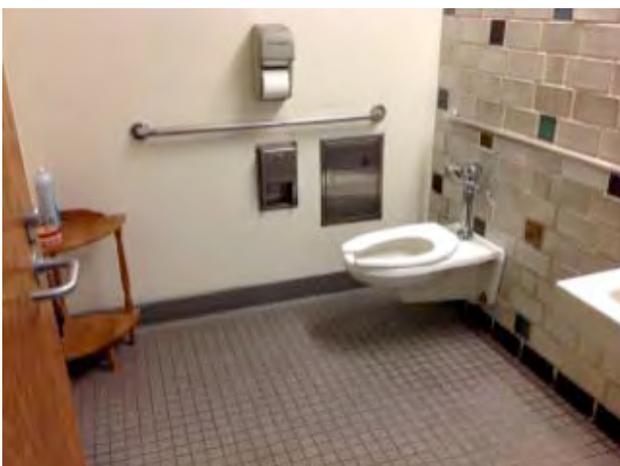
Photo 11

In the single-user toilet rooms for faculty use, furniture obstructs the maneuvering clearance in the toilet room. (Photos 11 and 12)

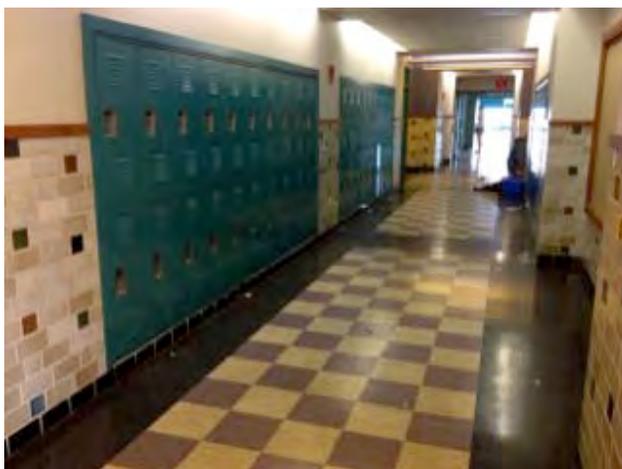
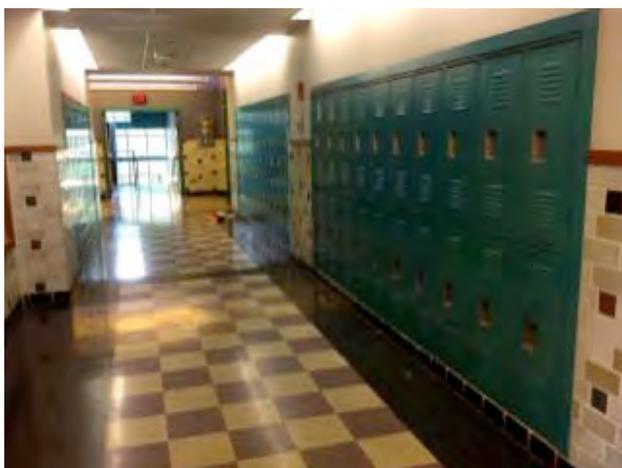
Photo 14

On all floor levels, lockers for student storage are found along corridors. Accessible lockers were not identified in this facility. (Photos 14 and 15)

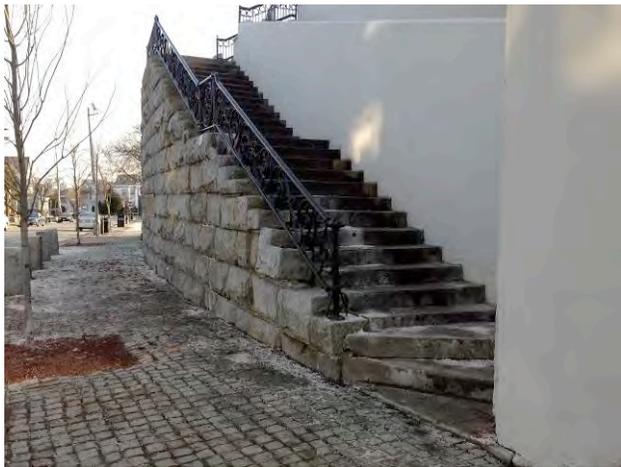
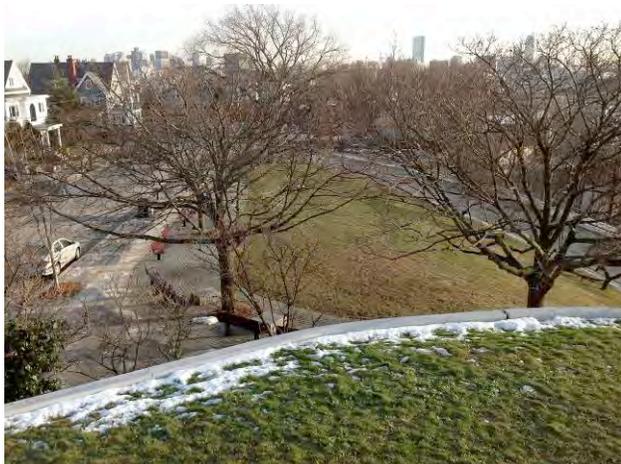
Photo 2

Two sets of stone stairways connect the sidewalk along Monroe Street to the base of the tower, which is used as a viewing platform by the public. (Photos 2 and 3)

This facility offers no accessibility features.

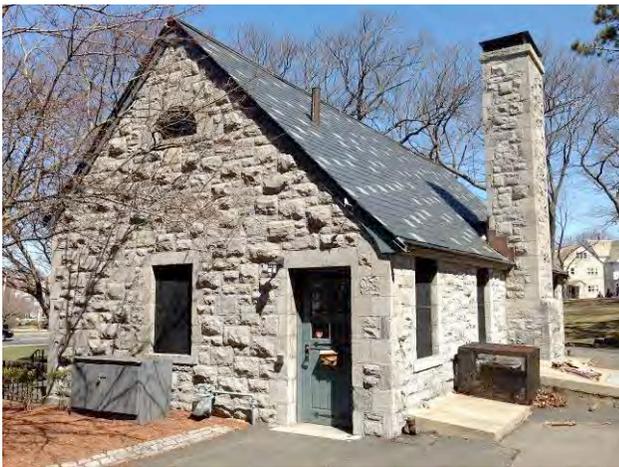
Photo 2

This facility has two entrances facing College Avenue that are accessed via short stairways. At the rear of the building, an at-grade entrance with an automatic door offers an accessible route into the building. (Photo 2)

No signage directing visitors to the accessible entrance at the rear is provided at the inaccessible entrances.

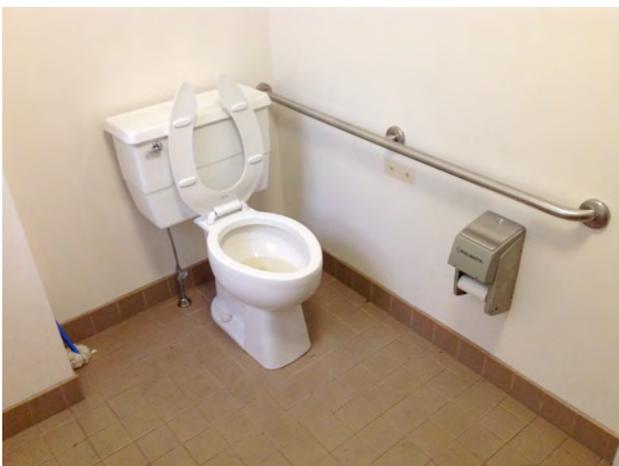
Photo 3

Although there has been an attempt to increase the accessibility in the toilet room with the installation of a few accessible features this space is not accessible. (Photo 3)

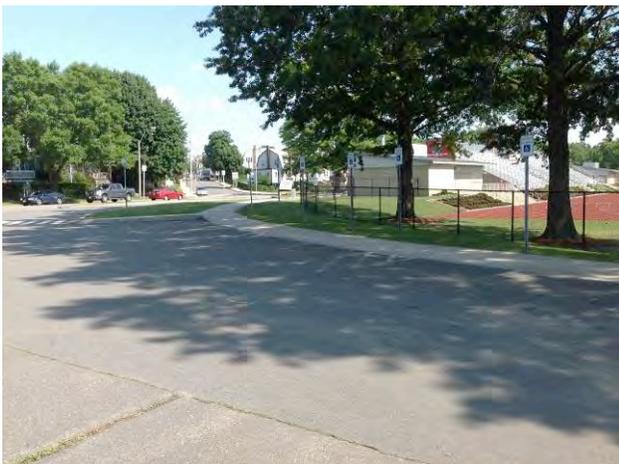
Photo 3

It appears that accessible parking spaces have not been maintained since the last renovation. The markings of all eight accessible parking spaces, which include two van designated spaces, are degraded and is not highly visible. (Photo 3)

1. At Dilboy Stadium, re-stripe parking spaces with missing or fading markings.

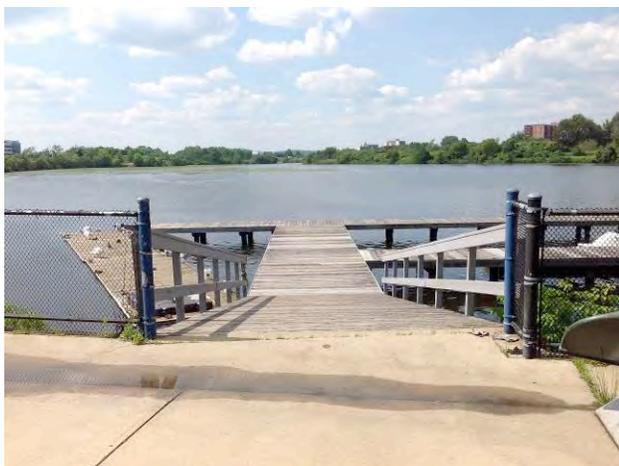
Photo 3

No accessible route is offered between the interior of the boat house and the boarding piers. Finally, this facility offers no accessible gangways or boat slips for residents with disabilities. (Photo 3)

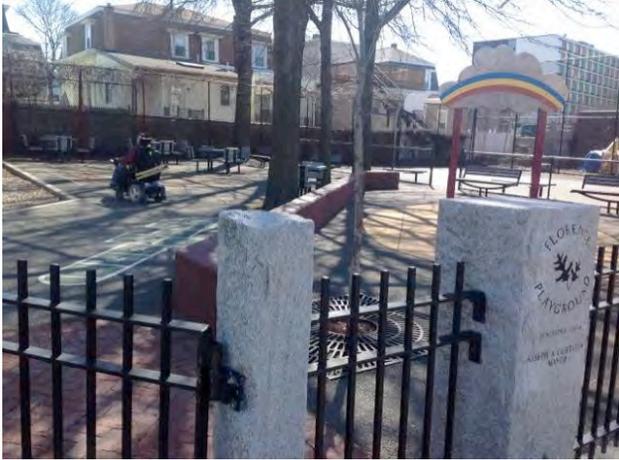
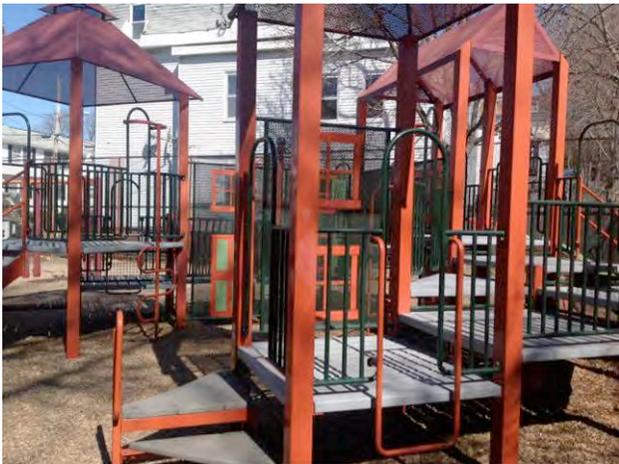
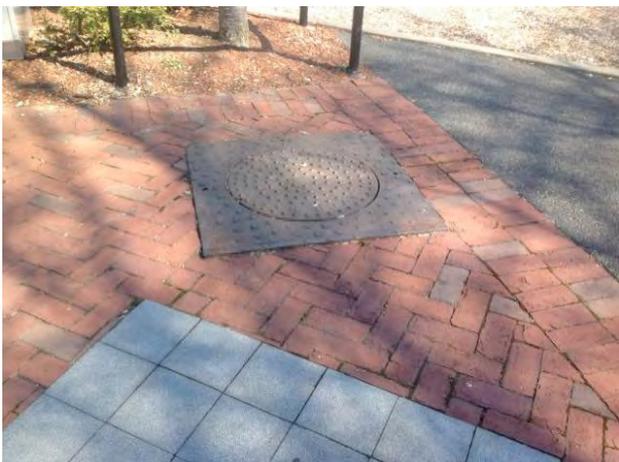
The nearly $\frac{3}{4}$ acre Edward Leathers Community Park features benches, accessible picnic tables, a few climbing elements and an off leash dog park. Some walkways are concrete while others are eroded stone dust paths. Barriers exist where paths have eroded or tree roots have surfaced. Additional, there is no accessible route to the stone seating circle wall.

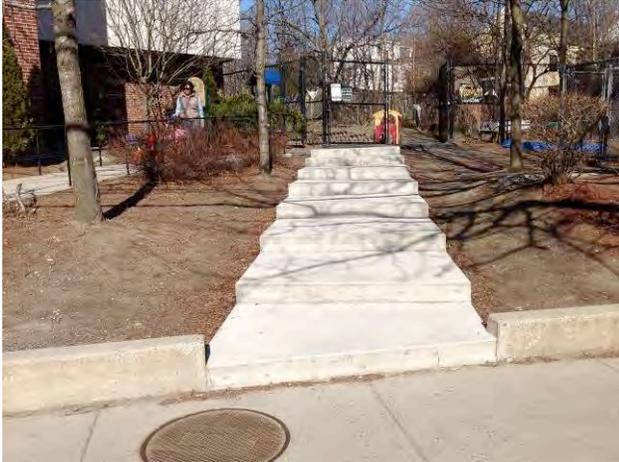
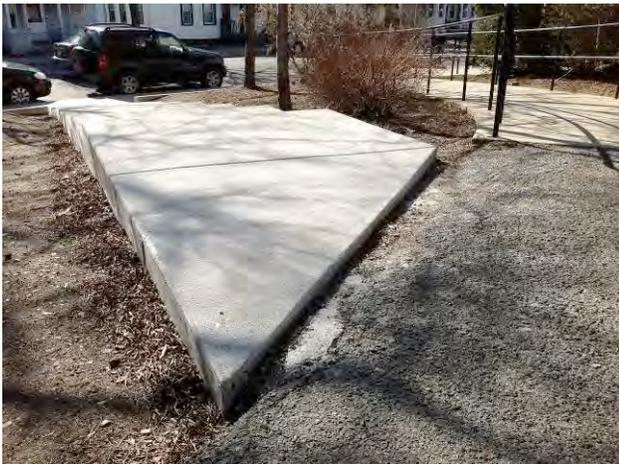
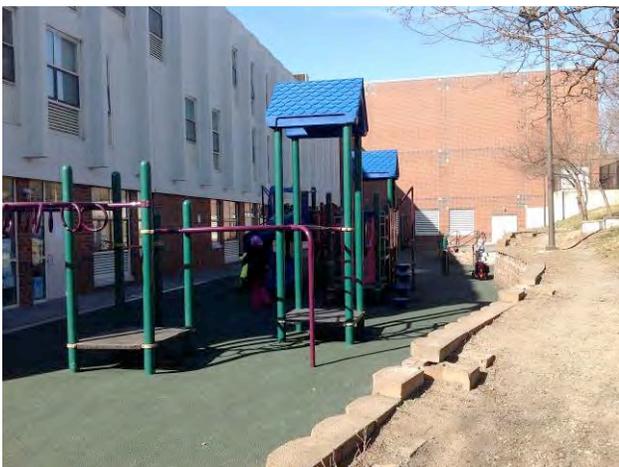
Hoyt-Sullivan Playground is a shady playground with two separate play areas and a basketball court. Most benches, play areas, and tables are not on an accessible route to entrance since much of the wood chip surface has not been maintained in recent years. Hoyt-Sullivan is occasionally the site for community activities.

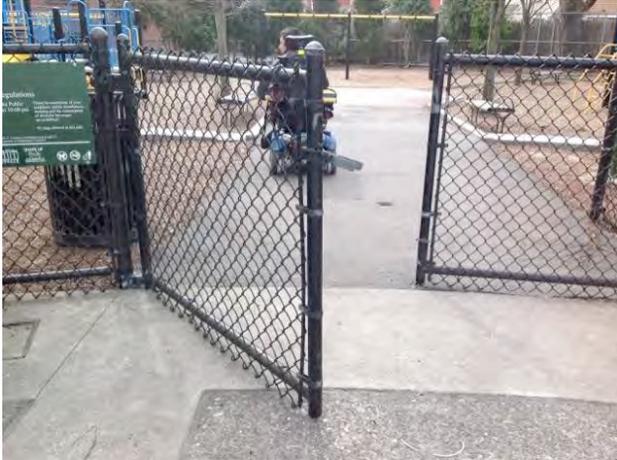
Photo 1

This large park has numerous grass and sports field areas as well as a basketball court. There are many paved path on which to travel throughout the park; however, these are poorly maintained, particularly in the area farthest from the school, and make use of the paths difficult for wheelchair users.

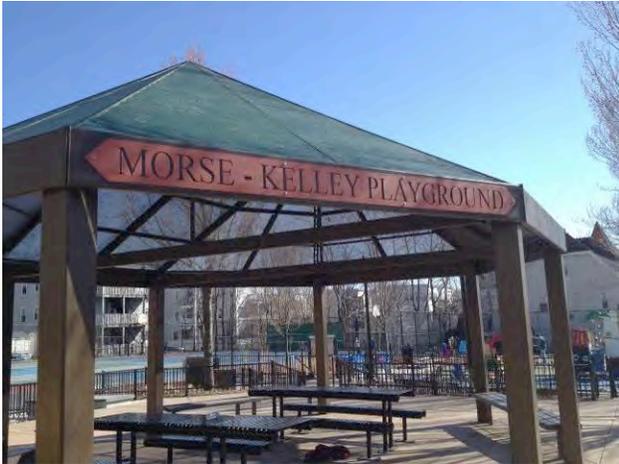
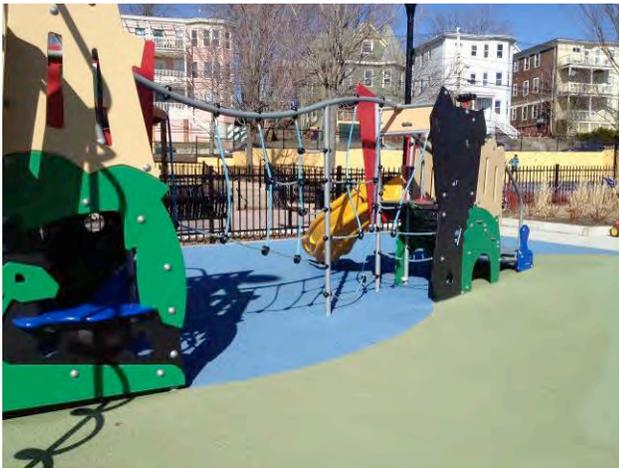
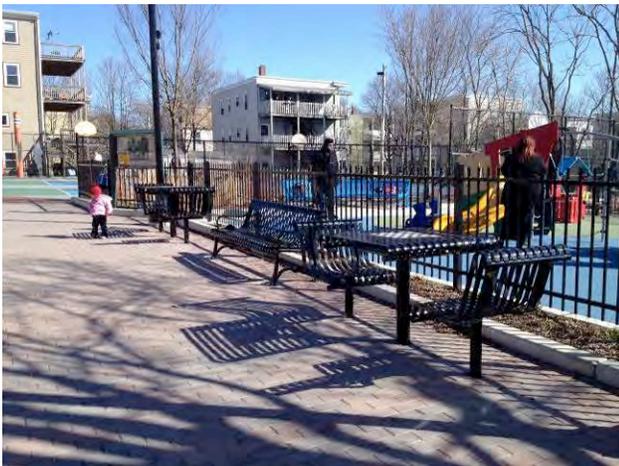
- Benches: 11 provided, 8 not on accessible route, all lack clear space along side
- Picnic tables: Not on accessible route, on uneven ground surface

This playground has a small paved area near the entrance. The rest of playground is dirt covered with wood-chippings, including the locations of the play structure and the majority of the benches. The surfaces under some of the benches and picnic tables have eroded significantly causing uneven ground levels and benches to be two or more feet above the surface.

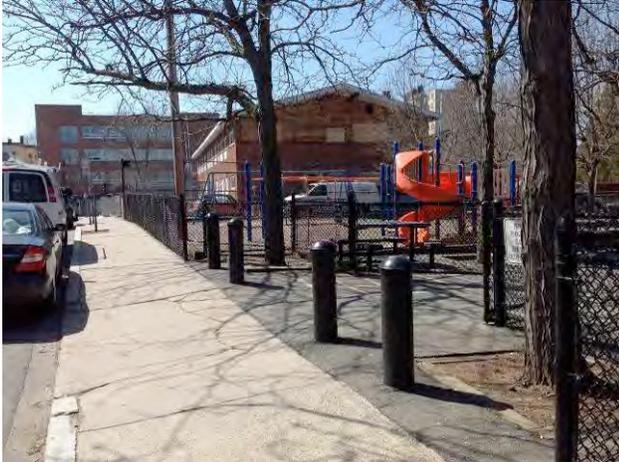
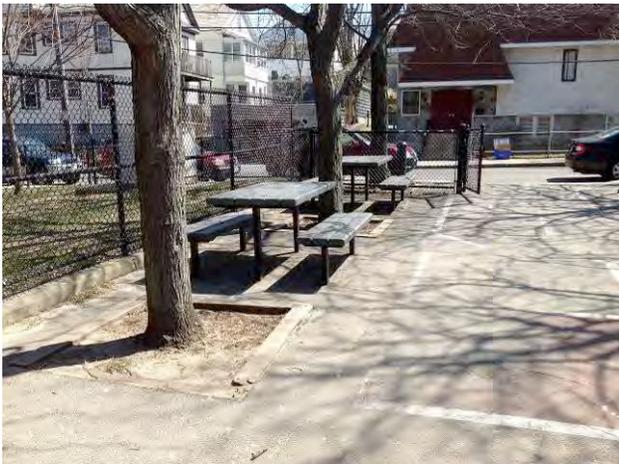
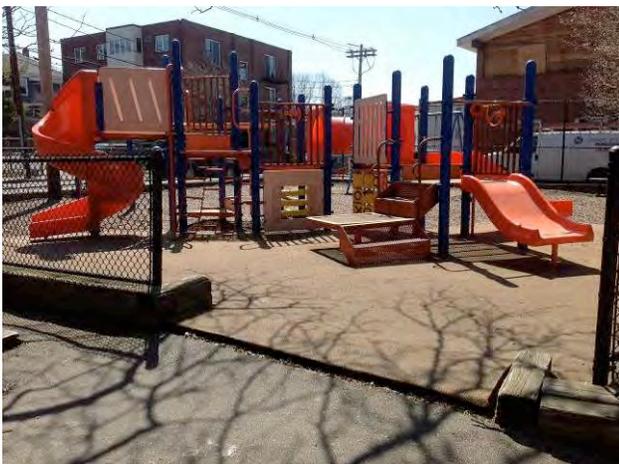
The Nathan Tufts / Powderhouse Park retains the graceful curving paths and stately landscaping intended by the original designers. Used mostly for passive recreation, it offers a peaceful respite from busy Powder House Square. The asphalt walkways can be steep at times and benches are not often placed on level surfaces. Stairways without handrails can be found at several points along the walkway.

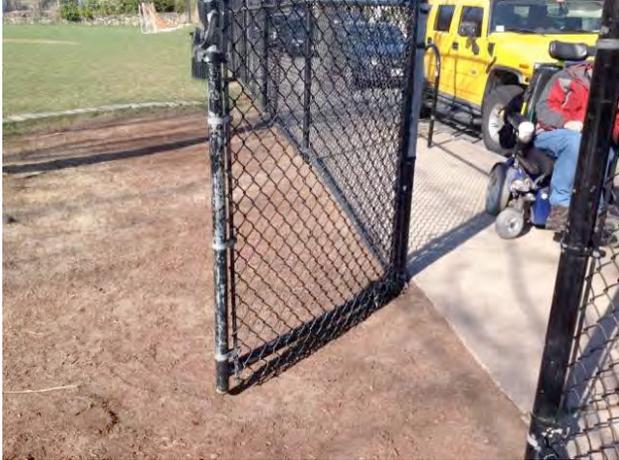
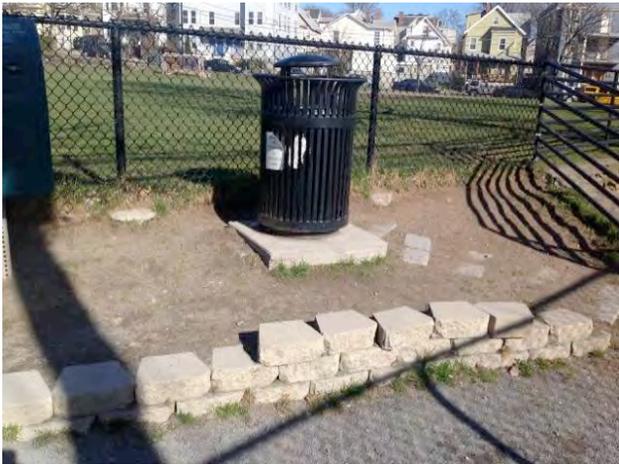
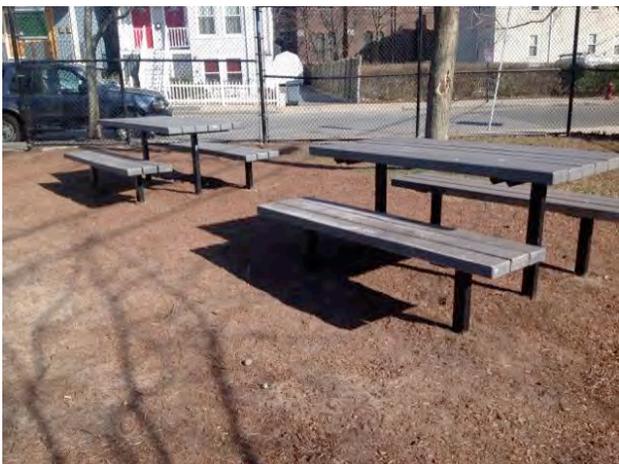
This local public park is located nearby the Veteran's Cemetery. It offers a playground, in addition to two basketball courts, hopscotch courts, and rest areas.

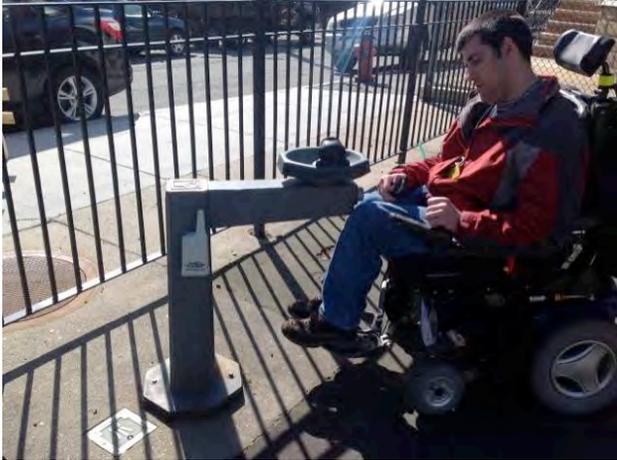
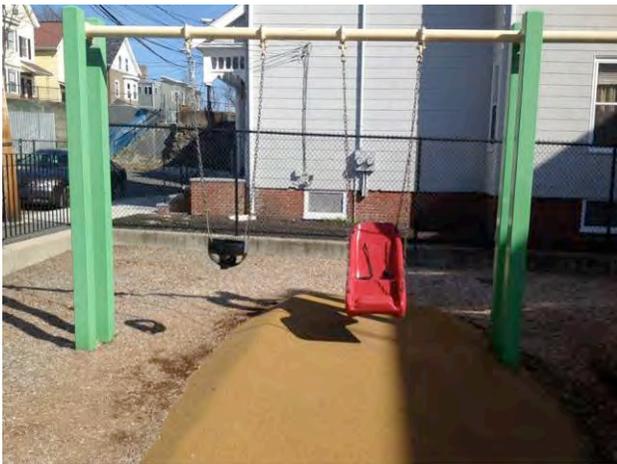
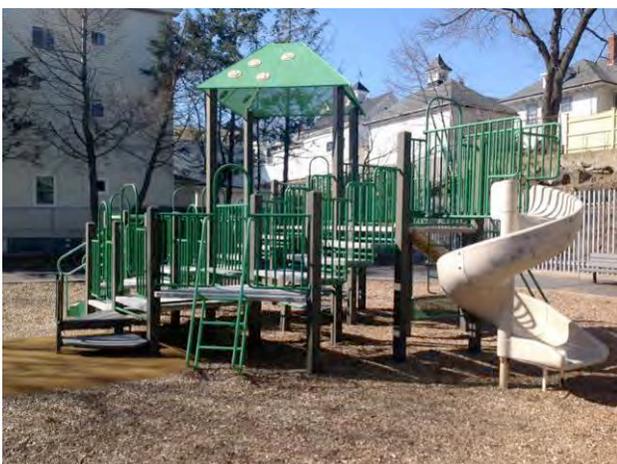
The majority of this park is a large field for general use with some picnic tables near one entrance. There is a smaller section of the park that is an off-leash section where local residents bring their dogs. Few features of this park are connected to an accessible route.

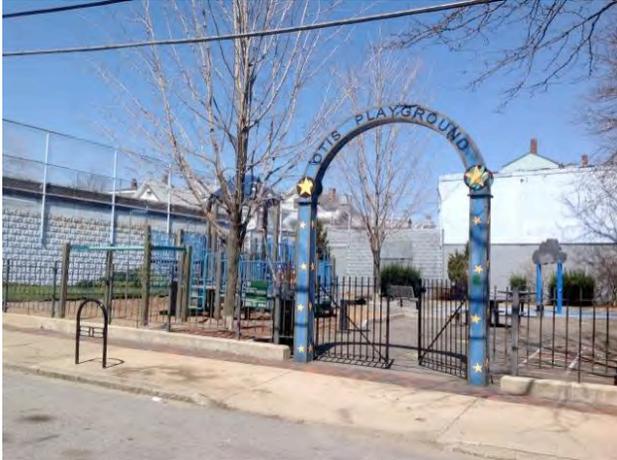
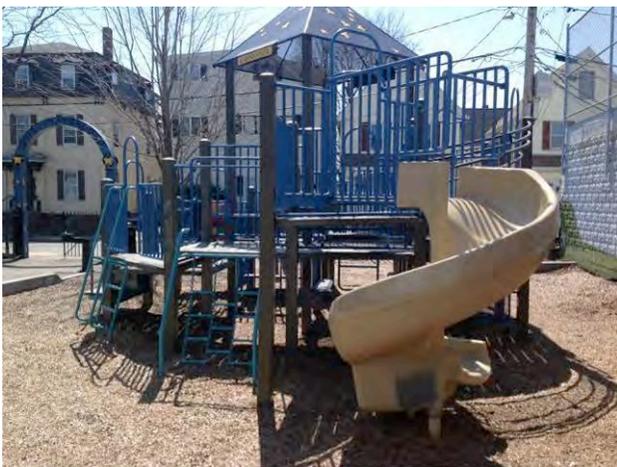
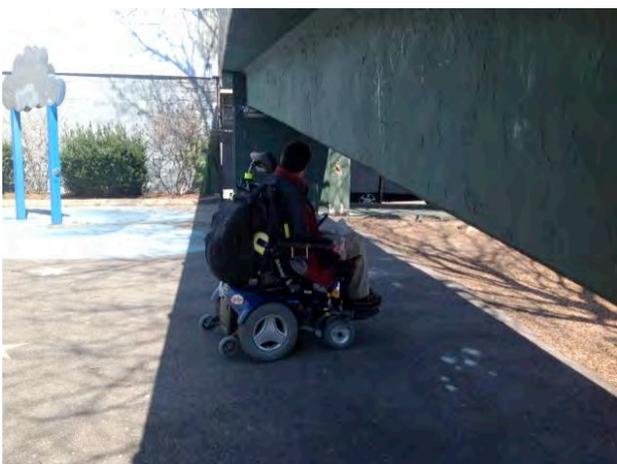
This park is split into two sections, one with a swing set and the other, across the road, with a large play structure. The walkways up to the swings and the play structure are made of a soft rubber that banks off sharply into woodchip making it precarious for individuals using wheelchairs or other mobility devices. Consequently, the width of the accessible surface is insufficient to permit side transfers or turning around safely.

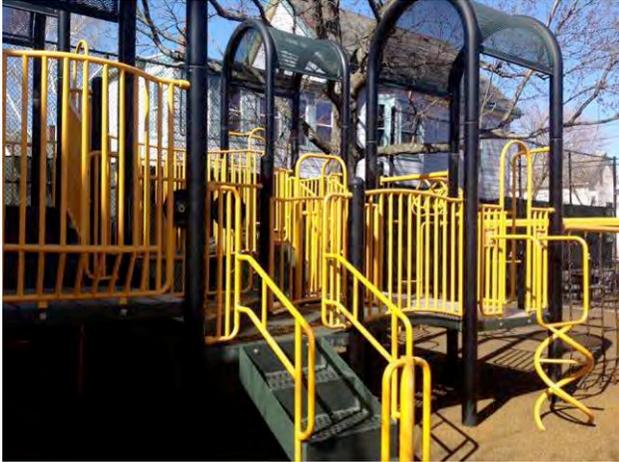
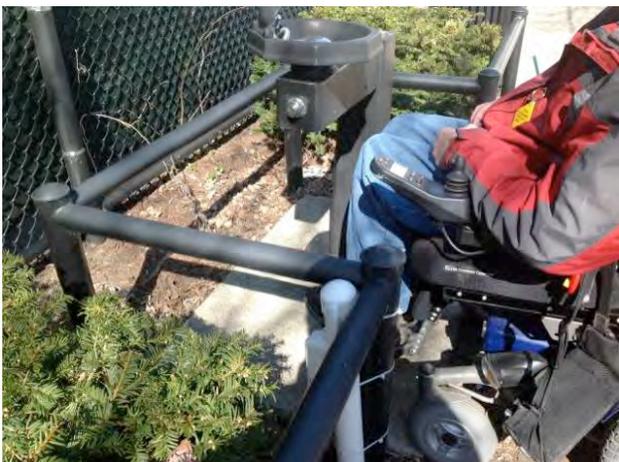
Located near McGrath Highway and adjacent to the inaccessible pedestrian overpass, Otis Playground has a large play structure as well as a water feature. There is also a swing set that is somewhat separated from the rest of playground by the ramp for the pedestrian bridge. Most of the ground space is paved, except for the wood chip covered area surrounding the play structure and the swings. The pedestrian bridge is an unprotected protruding object.

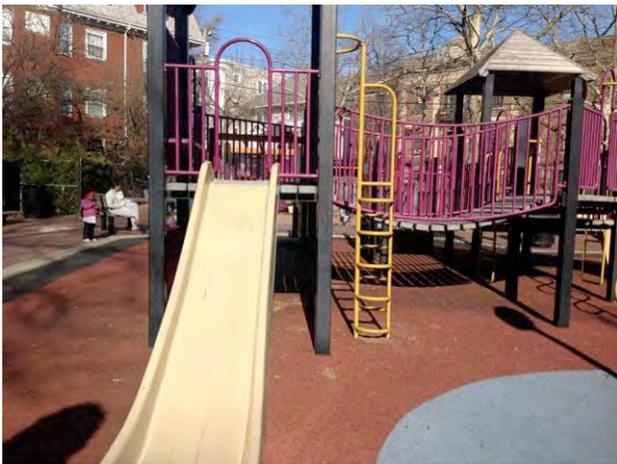
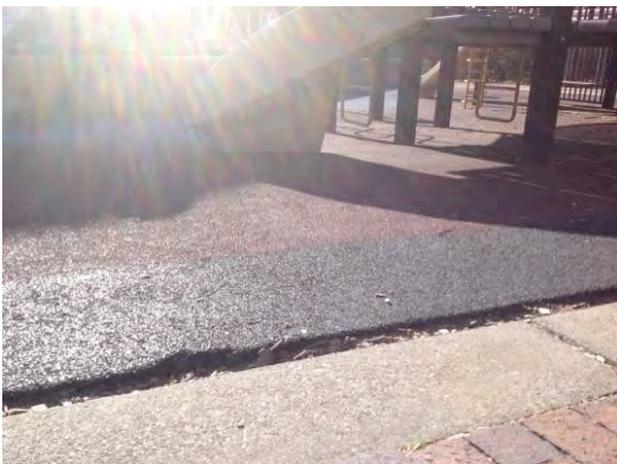
Walnut Street Park is slightly less than ¼ acre with benches and playground. Though mostly accessible, tripping hazards are present where surfaces meet.

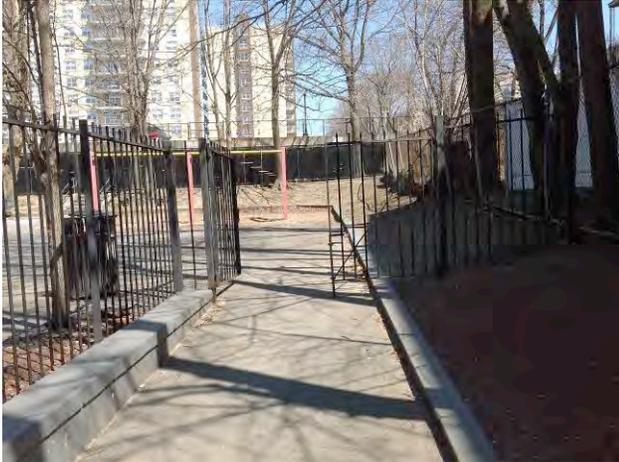
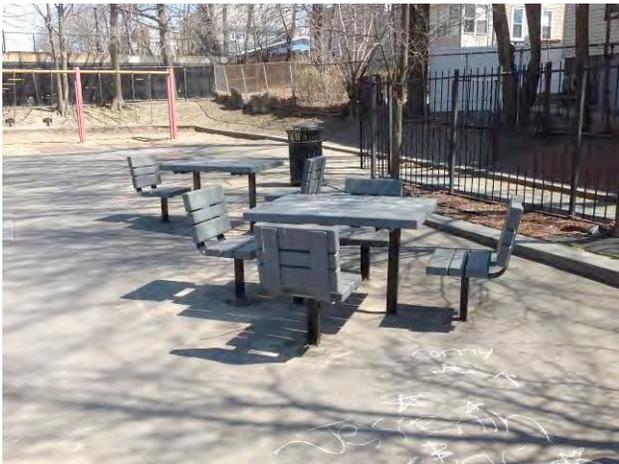
This expansive playground is located at the Winter Hill Community School. There are several basketball courts on different levels connected by ramps. The play structure sits at the highest level surrounded by a fence. The surface around the structure is wood chips and is the only non-paved portion of the playground.

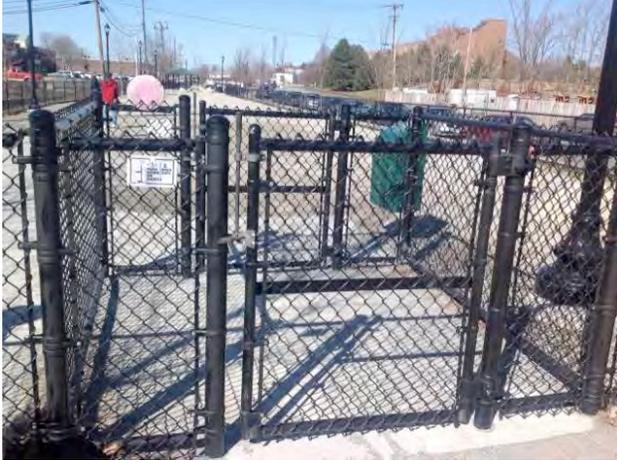
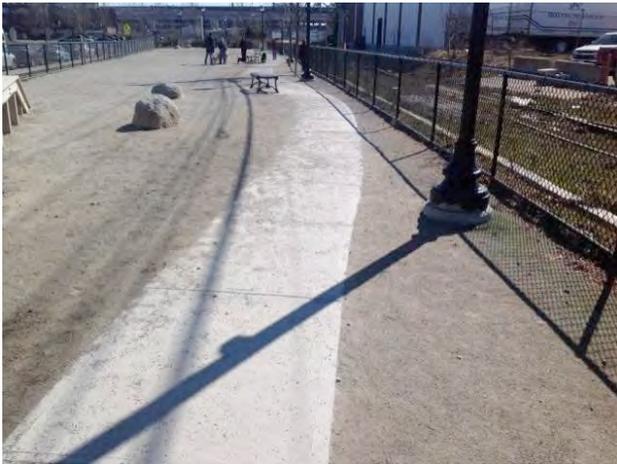
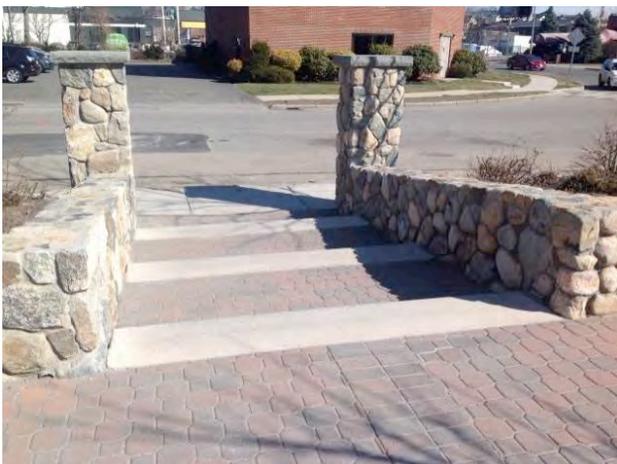
New Washington Dog Park is $\frac{3}{4}$ of an acre along the Inner Belt. It features numerous places to sit. Though new, three significant inaccessible conditions were identified: stairs without handrails; benches without an accessible space alongside; a walkway narrower than 60 inch but over 200 feet long without passing space.

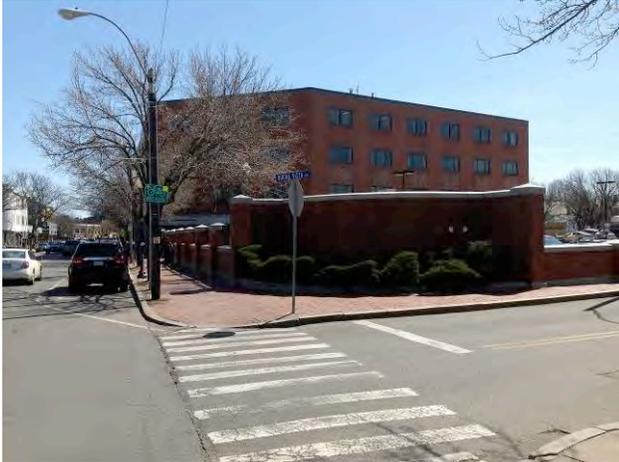
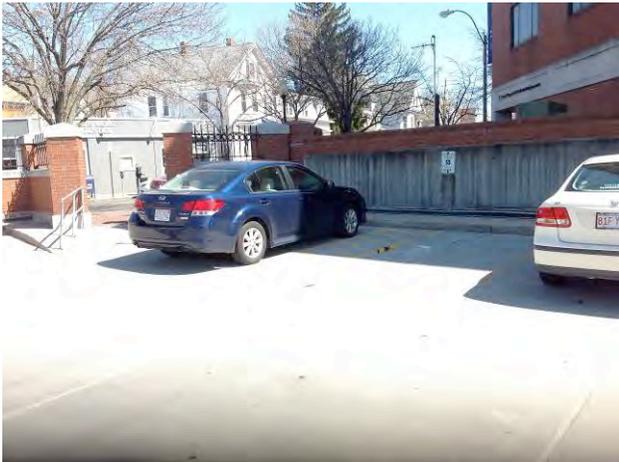
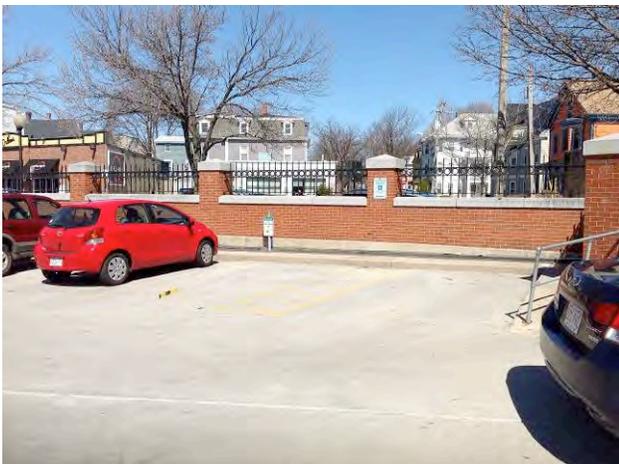
- No van designated space is provided
- Access aisles alongside parking spaces do not meet minimum allowable width
- Excessive slopes within parking spaces perpendicular to Holland Street
- Markings are not highly visible
- Signs are missing and or mounted below 60 inches above the ground

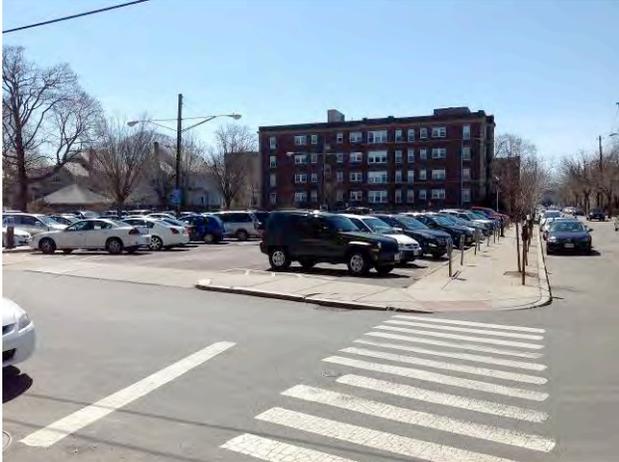
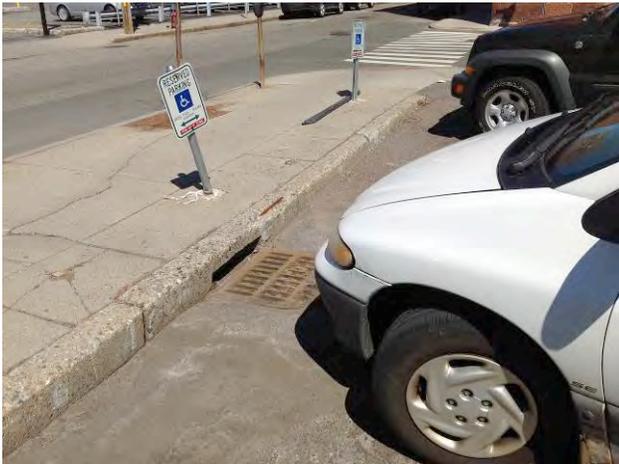
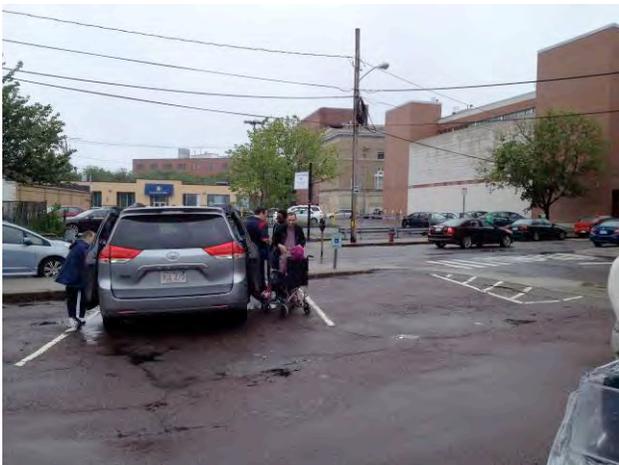
- No accessible parking space is provided
- Moderate to severe issues with sidewalks and walkways
- No accessible route is provided to the shaded seating area adjacent to this parking facility

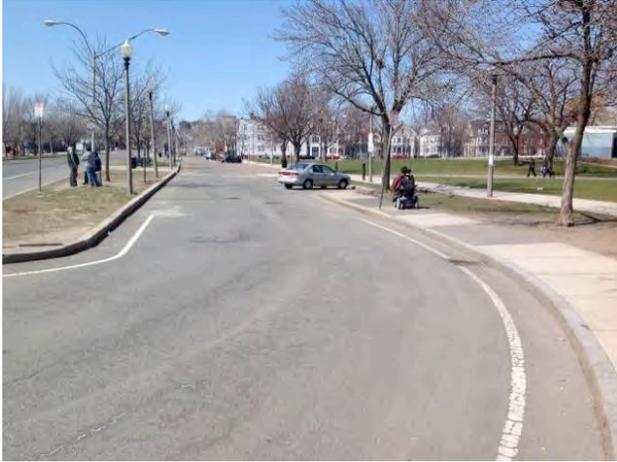
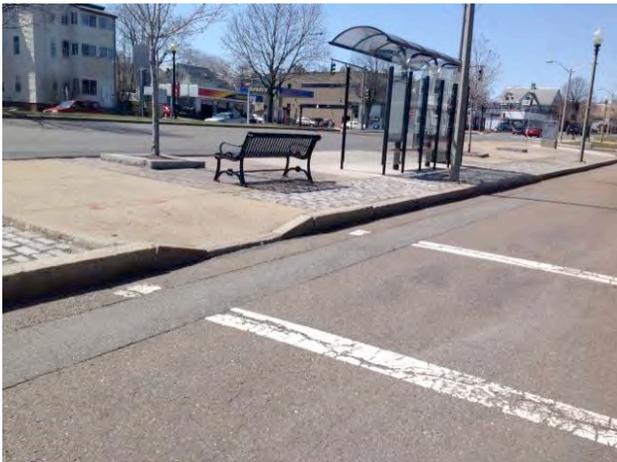
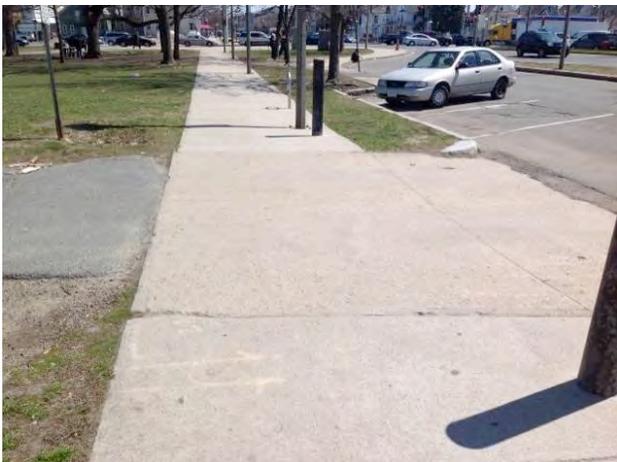
- No van designated space is provided
- Access aisles alongside parking spaces are not provided
- Excessive slopes within parking spaces, especially near the catch basin
- Signs, where provided are mounted below 60 inches above the ground

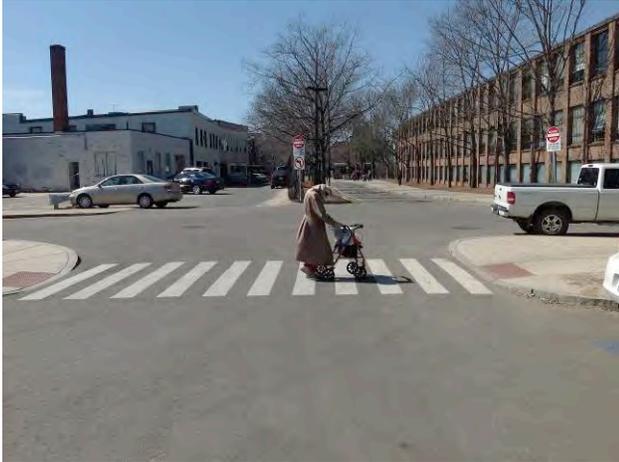
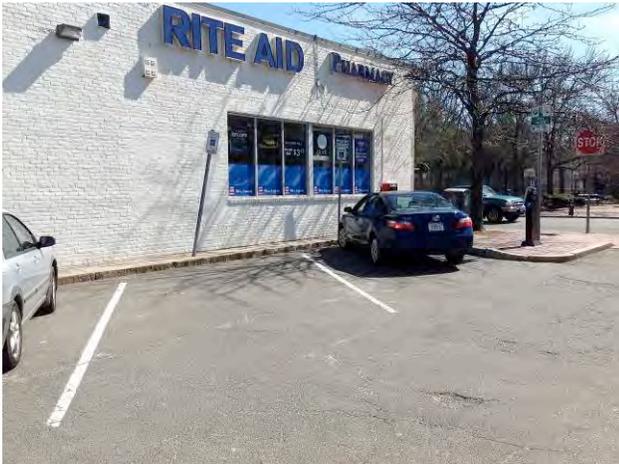
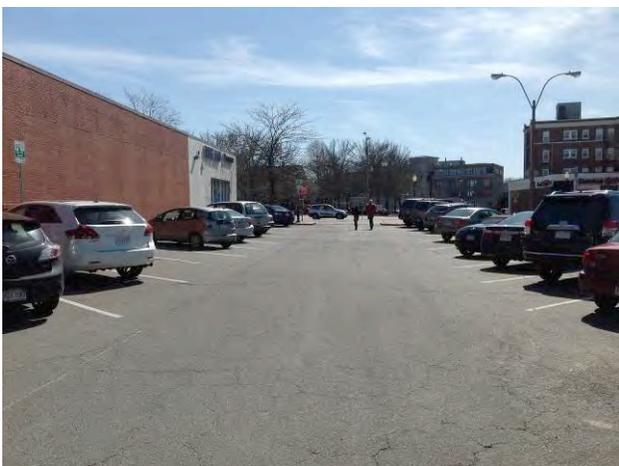
- Foss Park Parking Lot contains no accessible spaces.
- There are issues with 2-4" lips at curb cuts and access to the bus stop located on one of the island separating the parking lot from the main road.

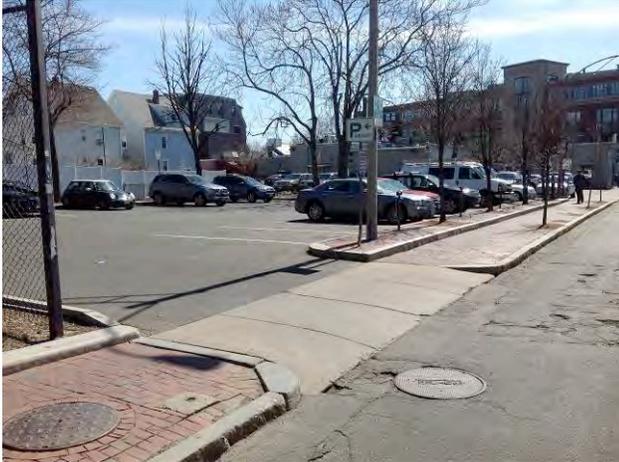
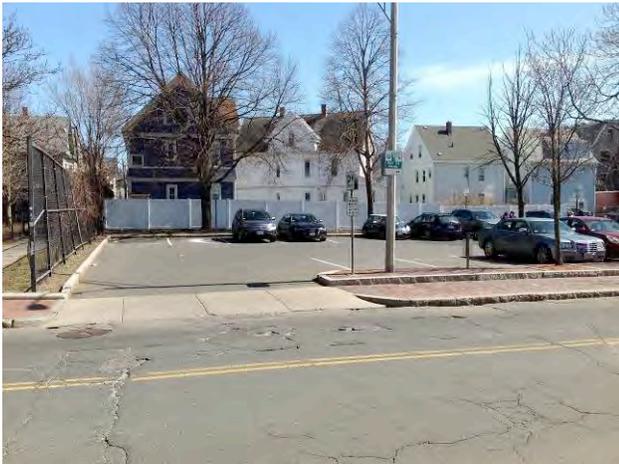
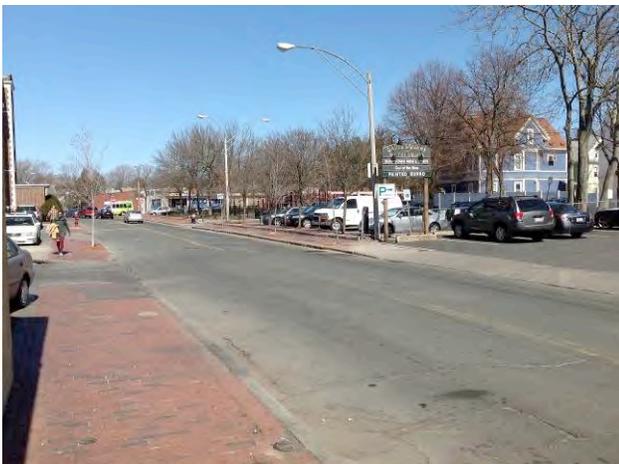
- Moderate issues with sidewalks and walkways
- No van designated space is provided
- Accessible parking spaces do not meet the minimum required number
- Access aisles alongside parking spaces are not provided

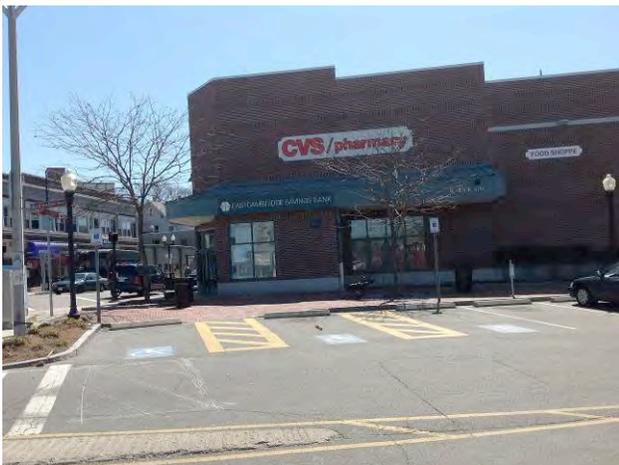
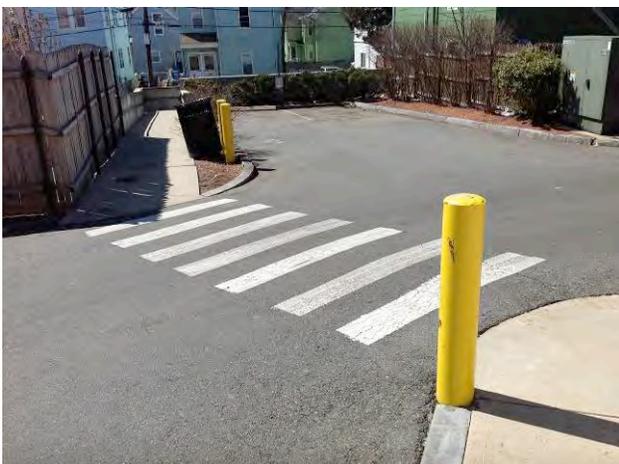
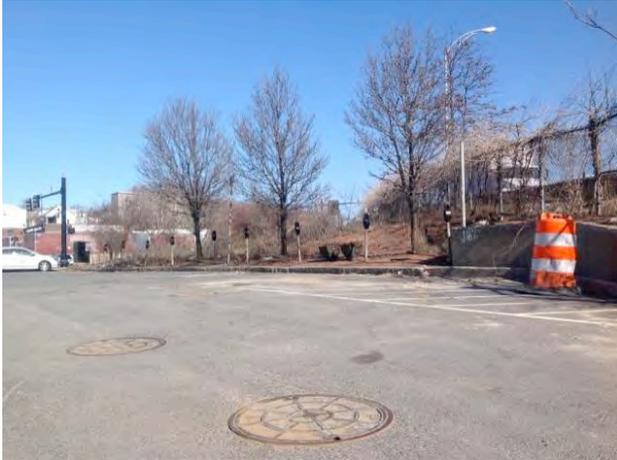
- No van designated space is provided
- Center and rightmost accessible parking spaces slightly exceed the maximum allowable slopes
- Access aisle on the right is too narrow and is not served by a curb ramp.
- Slightly excessive slopes within parking spaces
- Signs identifying the center accessible parking space is missing
- No accessible parking spaces are offered at other areas of the parking lot, including pedestrian access to Medford Street and Fisk Avenue

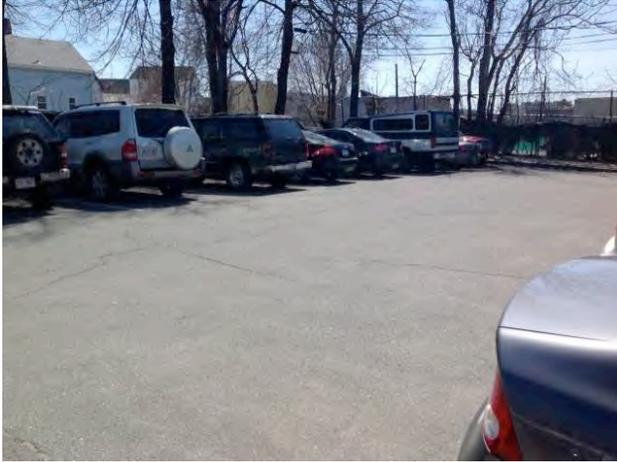
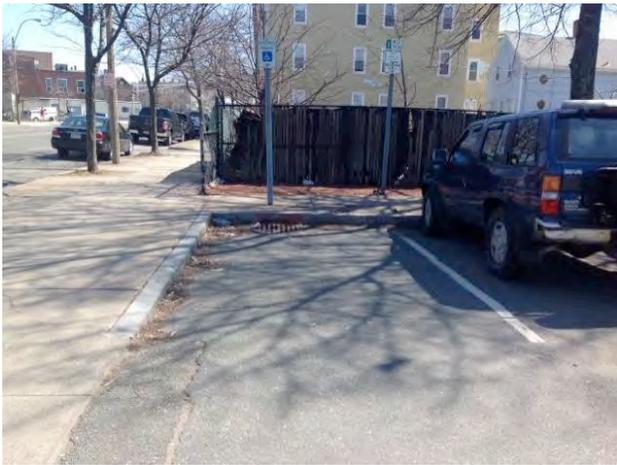
- No accessible parking spaces provided

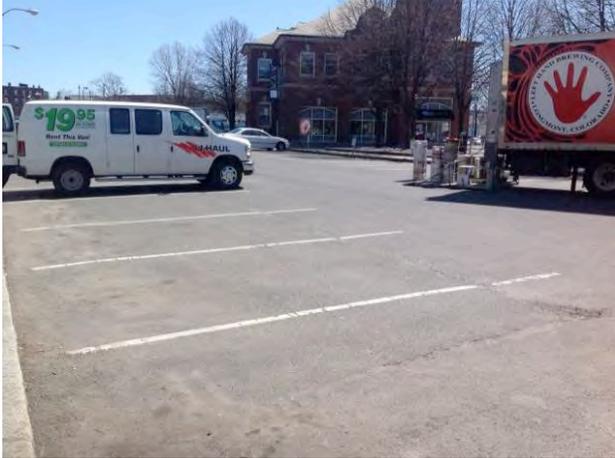
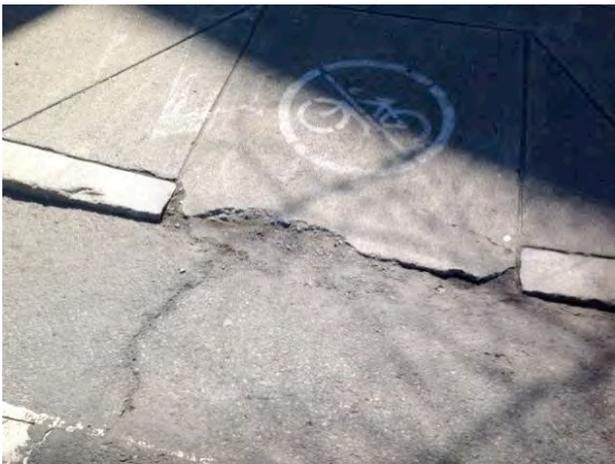
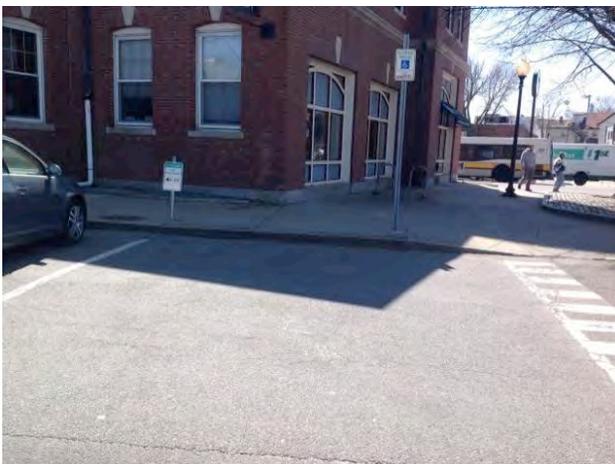
- Accessible space has no access aisle
- No van designated space
- The pavement is heaved and therefore not level. Other than the spots where the pavement is broken the surface of the parking lot is flat.

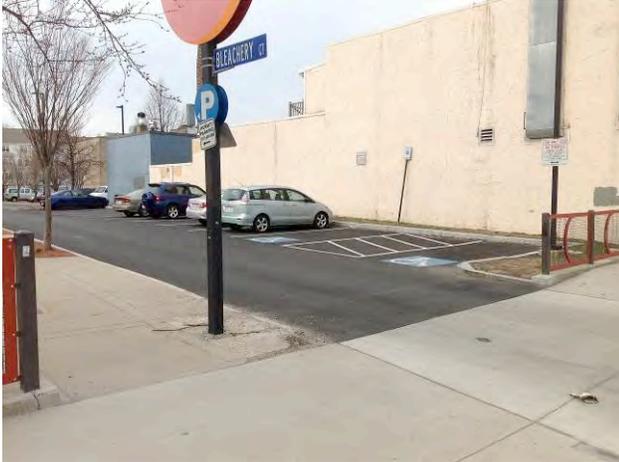
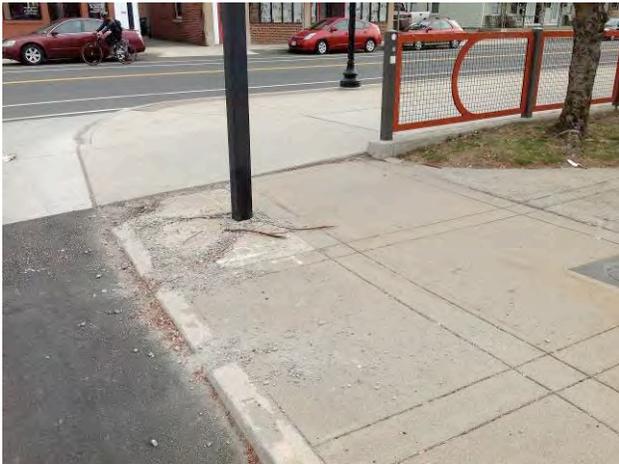
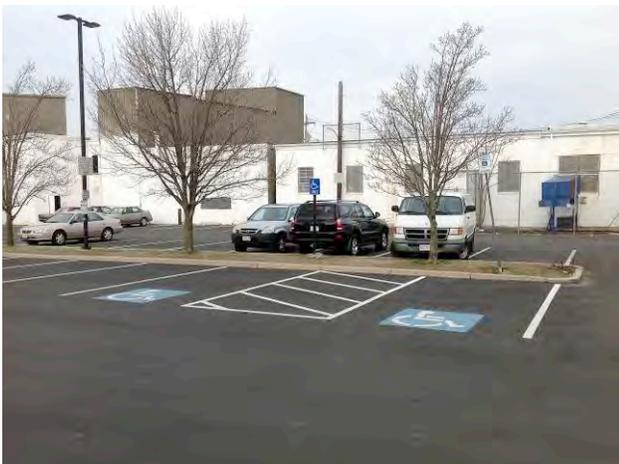
- No van designated space
- At least one accessible space is missing a striped access aisle.
- The curb cuts at the crosswalk have been broken down
